FIELD SERVICE BULLETIN

FSB# 160126

January 26, 2016

Affected Products: Sonoma, Tempus LX, Unison, Meridian, Tycho (all GPS-Synchronized)

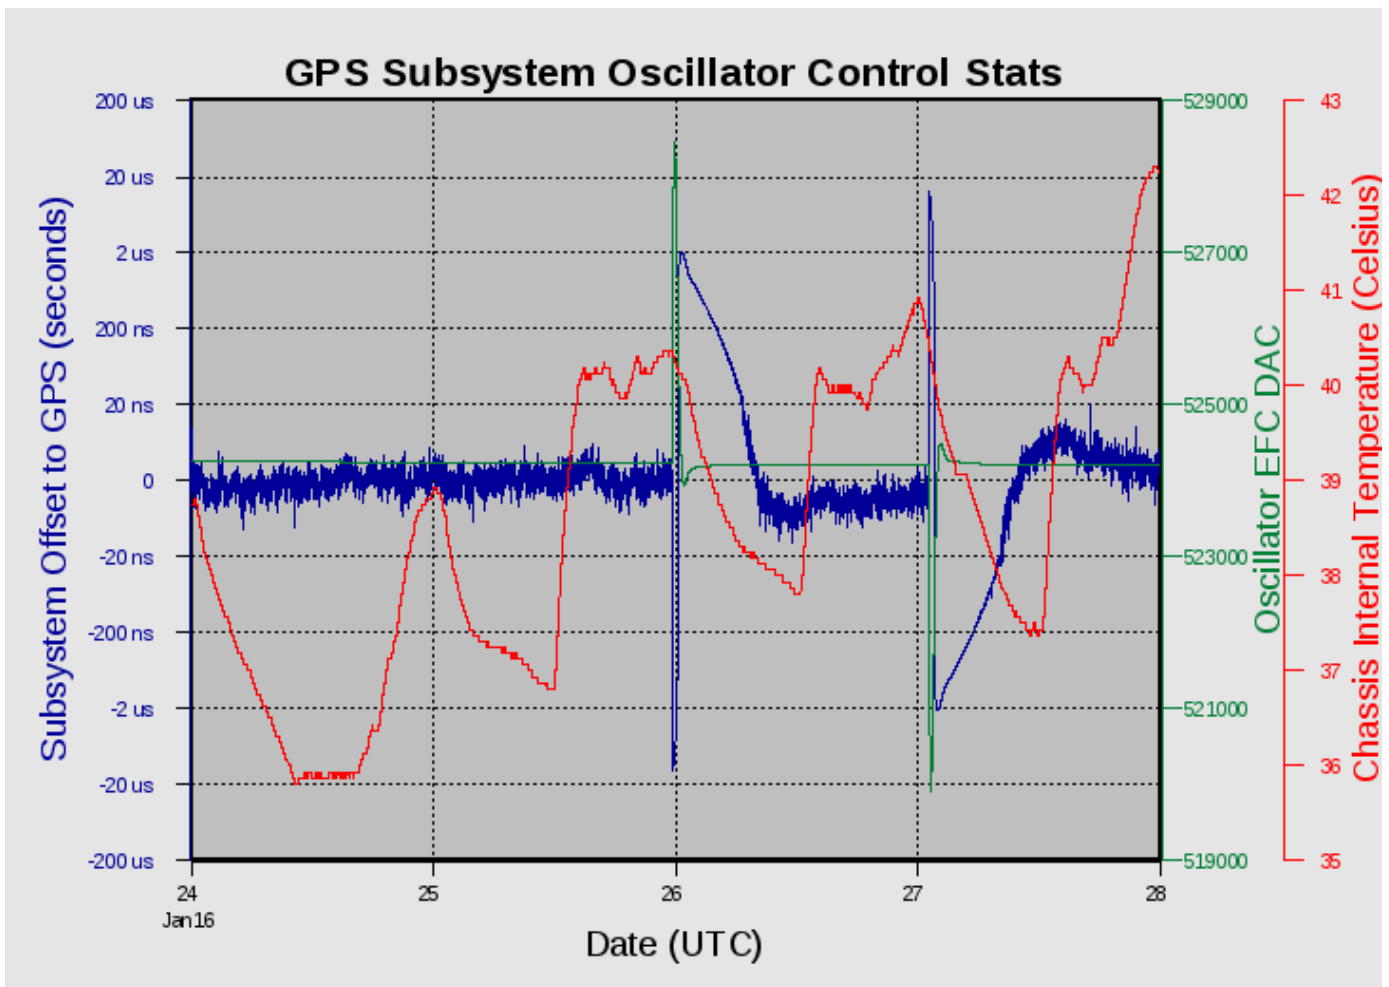
Temporary GPS system anomaly may have caused a UTC time step of 13.7 microseconds resulting in a TFOM level change and a Loss-Of-Lock Indicator.

The EndRun products listed above use a GPS receiver from a major GPS company that may have received the erroneous data and temporarily caused the timekeeping firmware to introduce a time step of approximately 13.7 microseconds to UTC. This is what caused the TFOM level change and the loss-of-lock indicator.

Following are plots from a Sonoma GPS Network Time Server and a Meridian II Precision TimeBase during the January 25 – 27 event period that were operating in EndRun's lab. The Sonoma plot illustrates the 13.7 microsecond time step and recovery. The Meridian II plot illustrates normal operation through the event.

For units with a TCXO, the loss-of-lock indicator was on for minutes. For units with an OCXO or rubidium, the loss-of-lock indicator was on for one to six hours. The EndRun products listed above that were affected self-recovered and removed the time step after receipt of a correct almanac shortly after 00:00 UTC Jan 27.

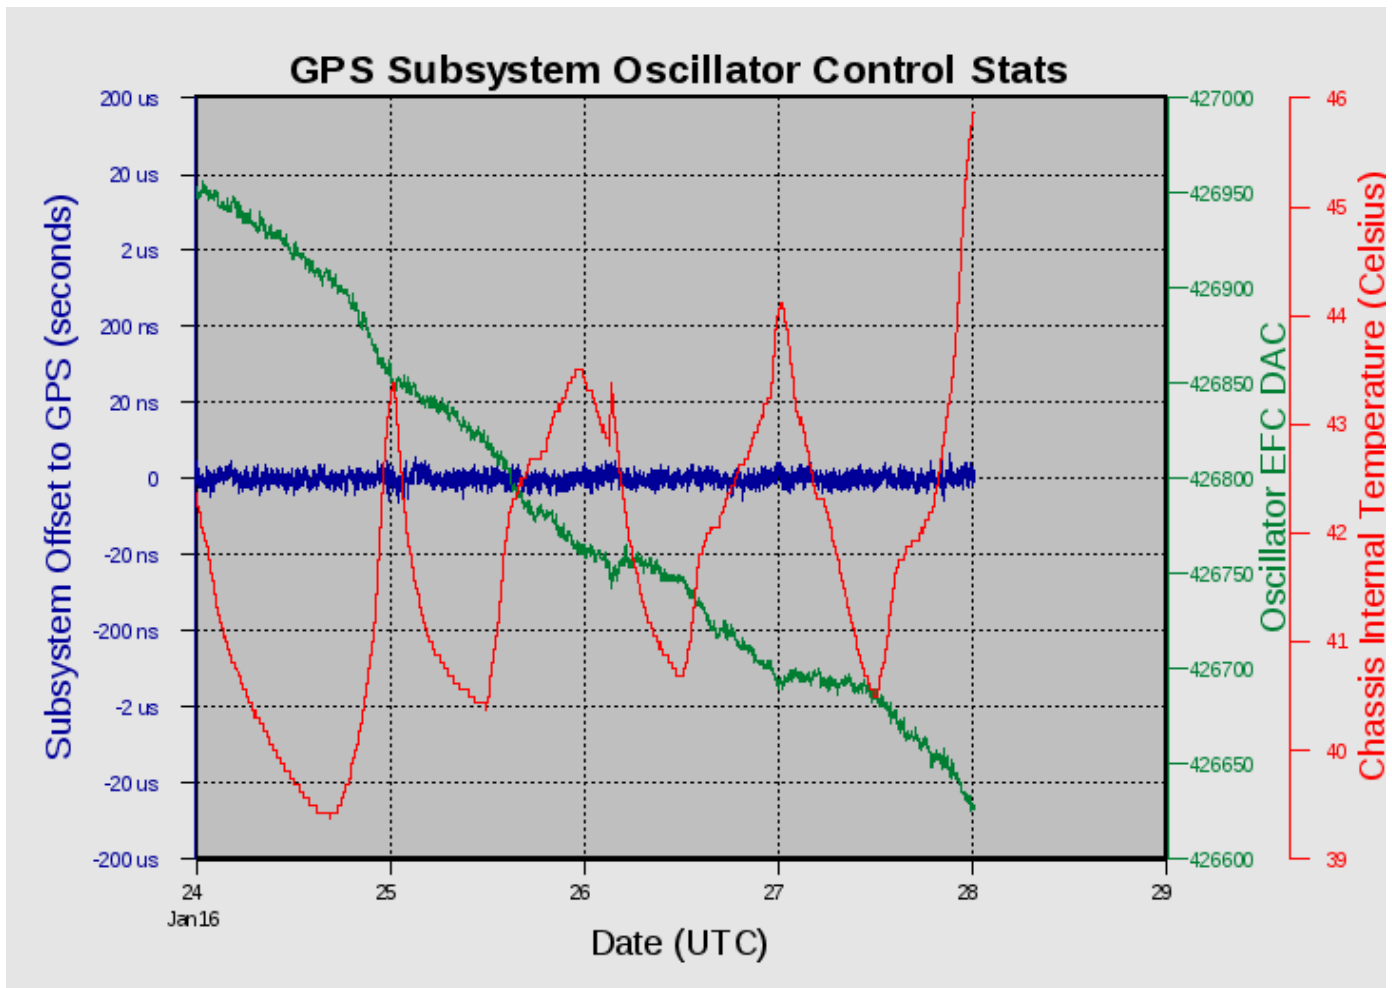
Meridian II Precision TimeBase

EndRun's Meridian II and Tycho II Precision TimeBase utilize EndRun's proprietary GPS receiver and were not impacted by this issue. The incorrect almanac data set was rejected as it did not pass the GPS receiver's integrity checks.
